JACOB BEATY and JESSICA BEATY, on  
behalf of themselves and all others similarly  
situated,

FORD MOTOR COMPANY,

Case No. 3:17-v-05201 RBL

**REBUTTAL REPORT OF THOMAS READ**

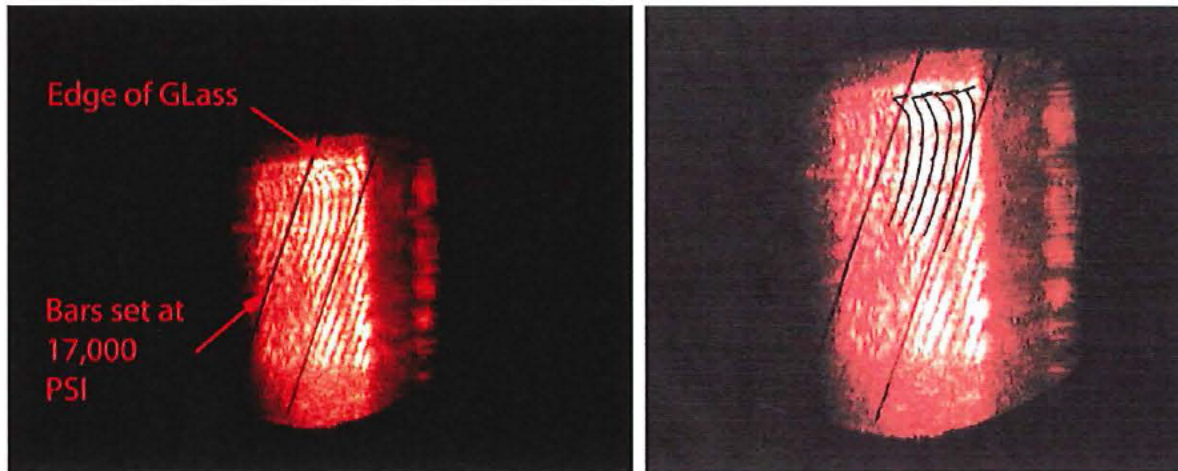
Figure #2: GASP measurements near the edge of a tempered glass panel. The GASP uses fringes to measure the surface stresses of tempered glass. One can see that direction of the fringes changes at the edge.

The GASP measurement shows that the compressive stress lessens as one moves toward the edge of the glass plate, and the area near the edge has very low or no compressive stress. Naturally, this means that the core tensile stress is increasing closer to the glass surface at the edge, which makes the glass more vulnerable to damage and self-destruction as glass only fails in tension.

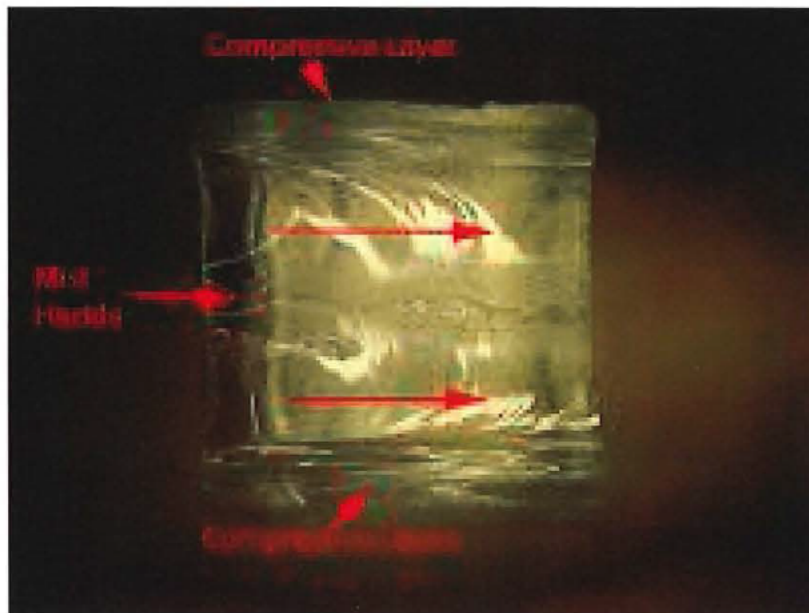
Figure #3: Representative fracture surface created when a fully tempered glass object fails. The mist hackle at center thickness indicates that the crack is traveling at its maximum velocity (3600mph).

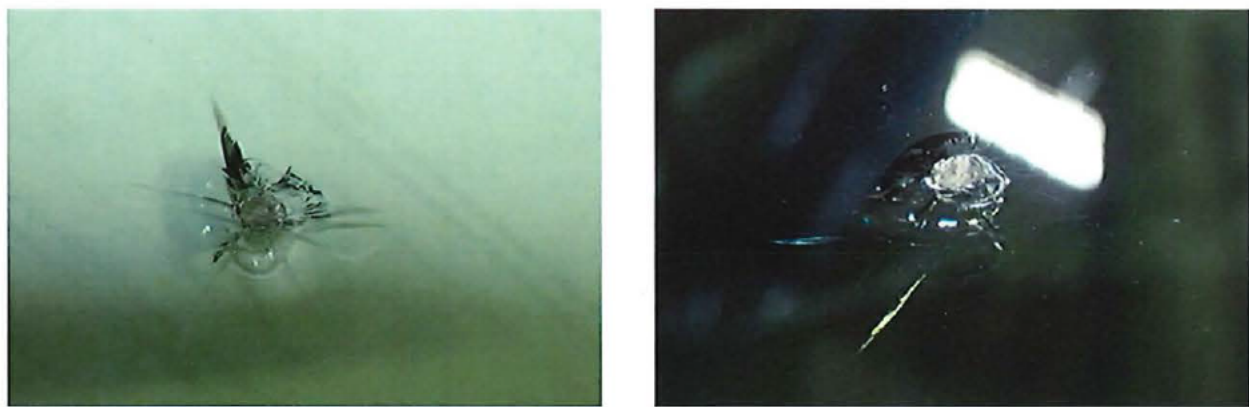
Figure #4: Part of Figure 11 from the Verghese report.

The windshield has a more vertical orientation than the PSR, so the impact is direct and almost perpendicular to the glass. It is important to note that the glass has chipped, but it did not self-destruct. Although tempered glass is stronger, it cannot survive damage that penetrates the compressive layer.

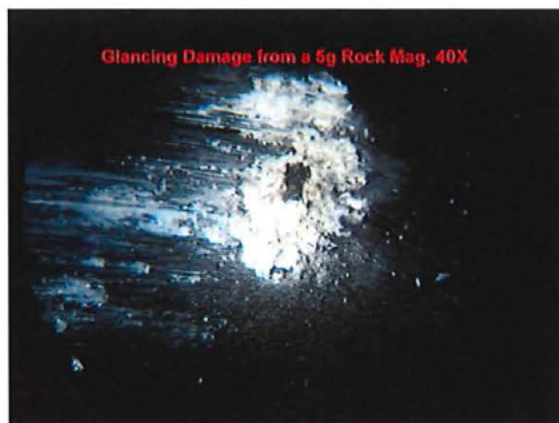
The pictures that Dr. Verghese presented of the Howd vehicle show that the fracture had to fail in a progressive manner because, as shown below, the scuffing that occurred to the Howd vehicle could not cause immediate failure. In order to assess the evaluation that Dr. Verghese performed on the Howd vehicle, I conducted a test involving damage to tempered glass from a stone traveling at an approximate 30-degree angle in excess of 85 mph, which shows scuffing damage to the glass that is similar to the scuffing that occurred to the Howd vehicle.

Had Dr. Verghese performed a complete glass failure analysis, the conclusion would have likely been that the complete fracture of the glass did not occur at the moment of impact, as shown in my testing in Figure 8 above. Instead, the scuffing would have simply caused a crack that would have continued to progress and cause instantaneous fracture once it penetrated to the tensile layer.

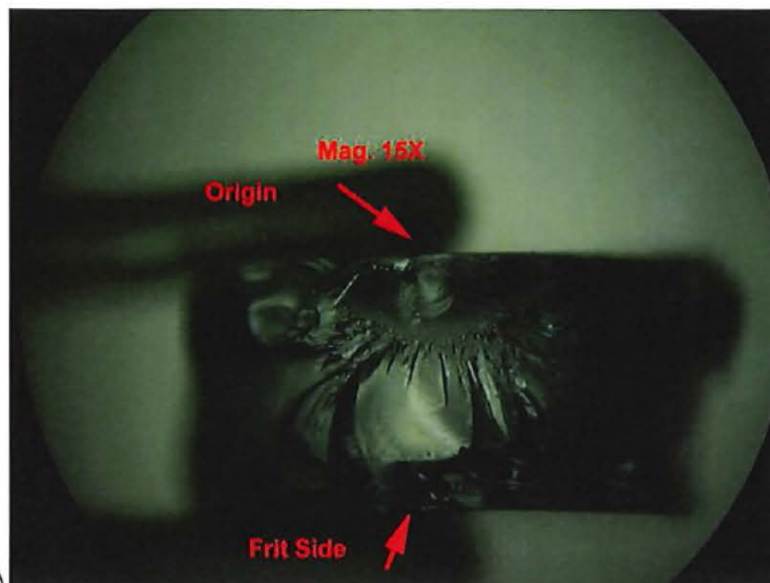
Figure #10: Photomicrograph of the origin of tempered glass oven door that was damaged with a diamond scribe and was then flexed and thermal shocked. The fracture originated on the side opposite the frit (i.e. the damaged side).

The damage origin in Figures #9 and 10 have the same appearance as many of the failed PSRs manufactured by Webasto and Inalfa that I have examined in this and other cases. The glass did not immediately fail catastrophically at the point of impact, but will instead fail catastrophically from progressive growth over time.

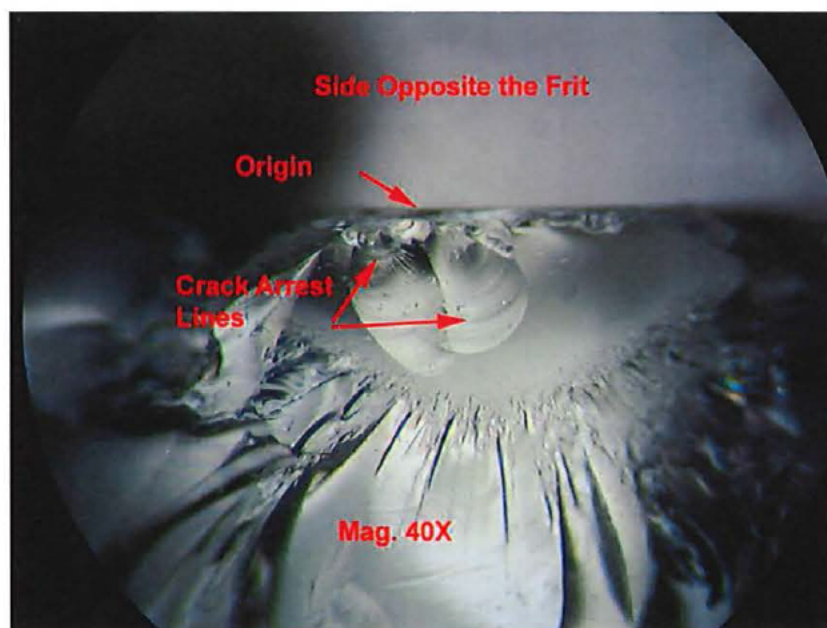
Figure #11: Higher magnification photomicrograph of the origin shown in Figure #10 above.
